Exterior Mechanical and Electrical Equipment

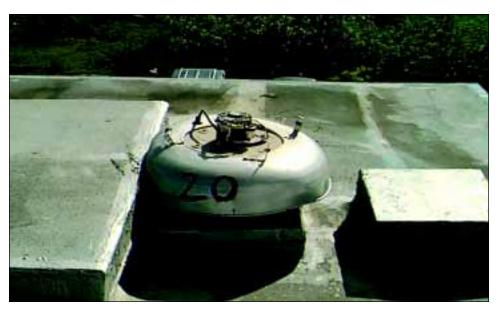
Hurricane Georges caused few problems to Puerto Rico's exterior-mounted mechanical and electrical equipment. The most commonly observed problem was blow-off of exhaust fan cowlings, as shown in Figure 6-1. Many residences and other buildings have water storage tanks on their roofs and most appeared to have performed well. However, as documented in Section 5.2.1, one tank blew off and damaged a hospital. Solar hot water heaters are located on many buildings and they also performed well. One solar heater that did not is shown in Figure 6-2.

FIGURE 6-1 This exhaust fan lost its cowling.

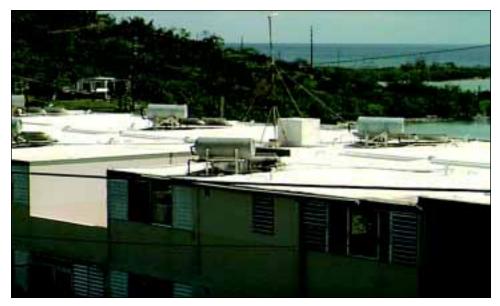
FIGURE 6-2 This roof had several solar hot water heaters that successfully weathered Hurricane Georges. However, the unit in the foreground was damaged.

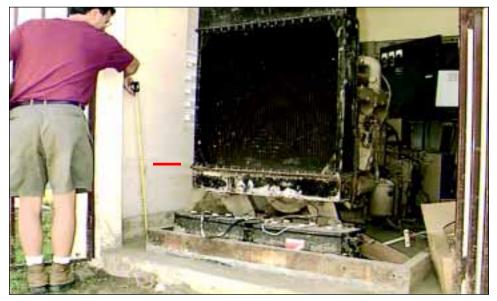
During Hurricane Georges, an emergency generator at a water treatment plant was flooded by a nearby river, rendering the generator unusable. As shown in Figure 6-3, the water rose approximately 2 feet above the generator room floor.

FIGURE 6-3 Flood water entered this generator room and reached a height of about 2 feet, as indicated by the red line. This facility is located in Jayuya.

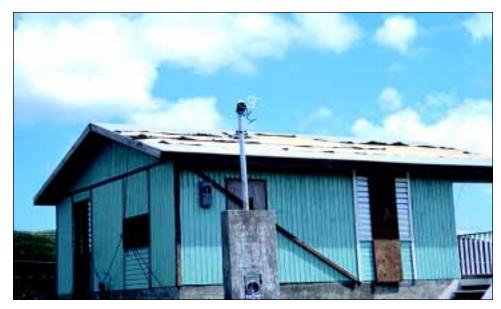
Several residences in Puerto Rico have overhead electrical service to a service mast mounted on a free-standing concrete pylon. From the service mast to the building, the service was underground, as shown in Figure 6-4. The advantage of this type of service mast versus one mounted through the roof is that if the mast deflects or is torn away, the roof is not damaged.

FIGURE 6-4 This service mast is mounted on a concrete pylon. This form of service connection was successful in eliminating roof damage when the overhead service blew down.
